## Perform Guard No. 6006

**Subject:** SIPS

## Perform Guard No. 6010

**Subject:** Field Testing

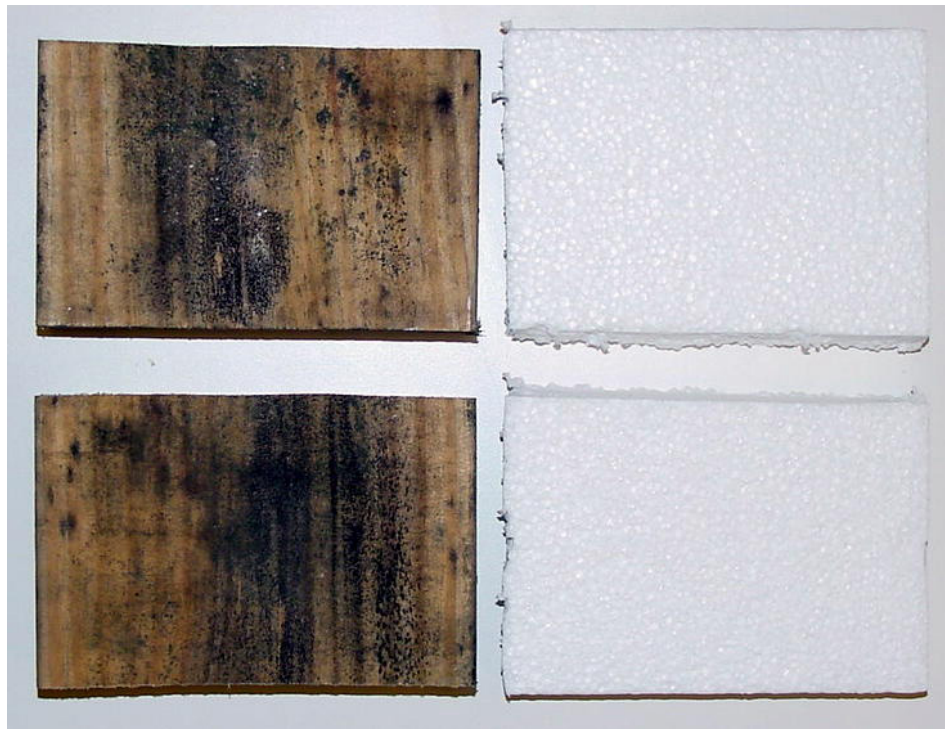
**Southern Yellow Pine  
with Mold Growth**

**R-Control SIPS with  
NO Mold Growth**

R-Control SIPS with Perform Guard sample, samples of southern yellow pine were tested as a control. At the end of the 3 month test, the growth of mold (Trichoderma and Aspergillus) was obvious on the southern yellow pine. NO mold growth was present on the R-Control SIPS with Perform Guard. Please also refer to Technical Bulletin MPS no. 1004.

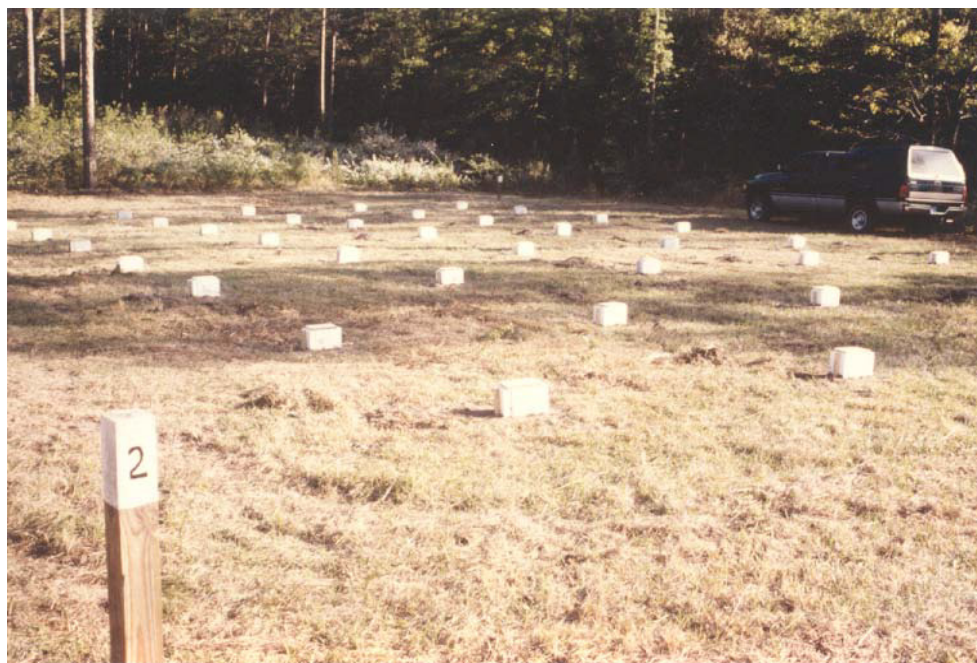
**Field installation of test textures - Stone County, Mississippi.**

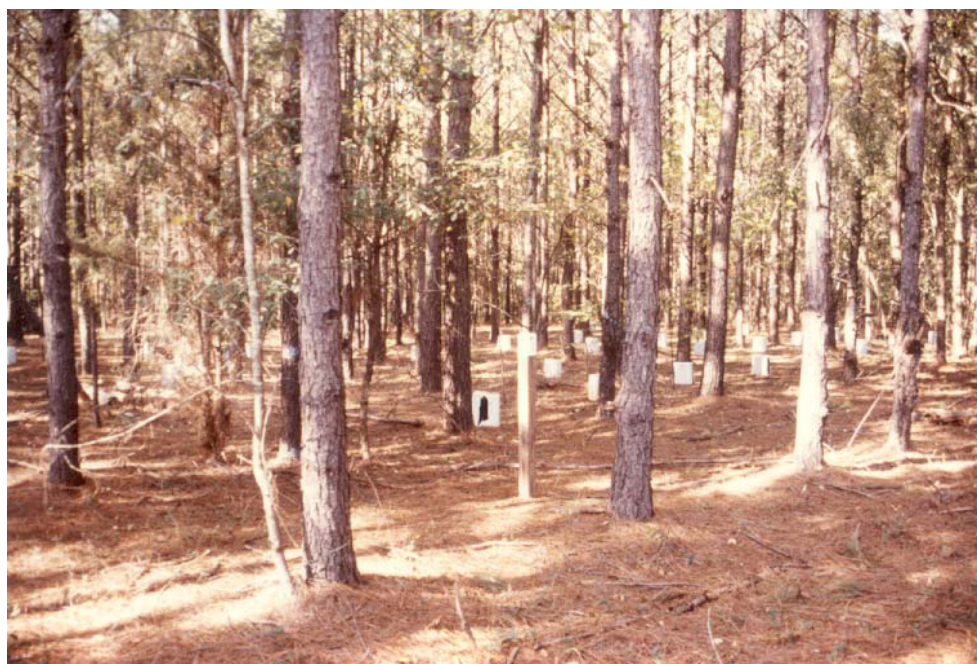
**Field installation of test textures - Griffin, Georgia.**

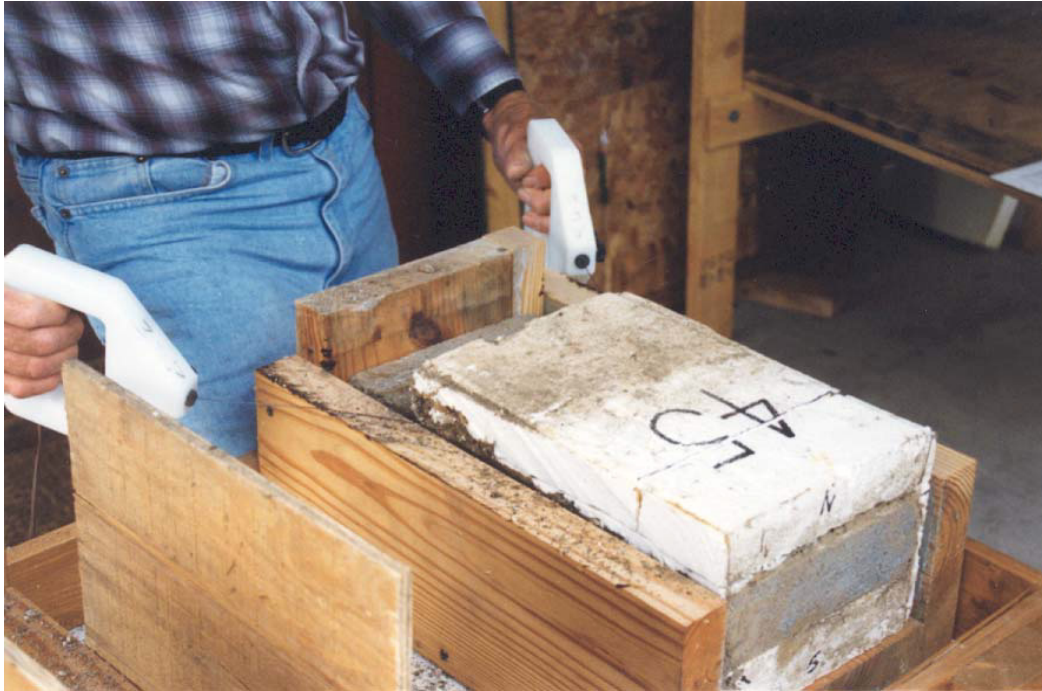
**#45 TEST FIXTURE - Examination of of non-treated EPS after 3 years exposure.  
Highland Site, Mississippi.**

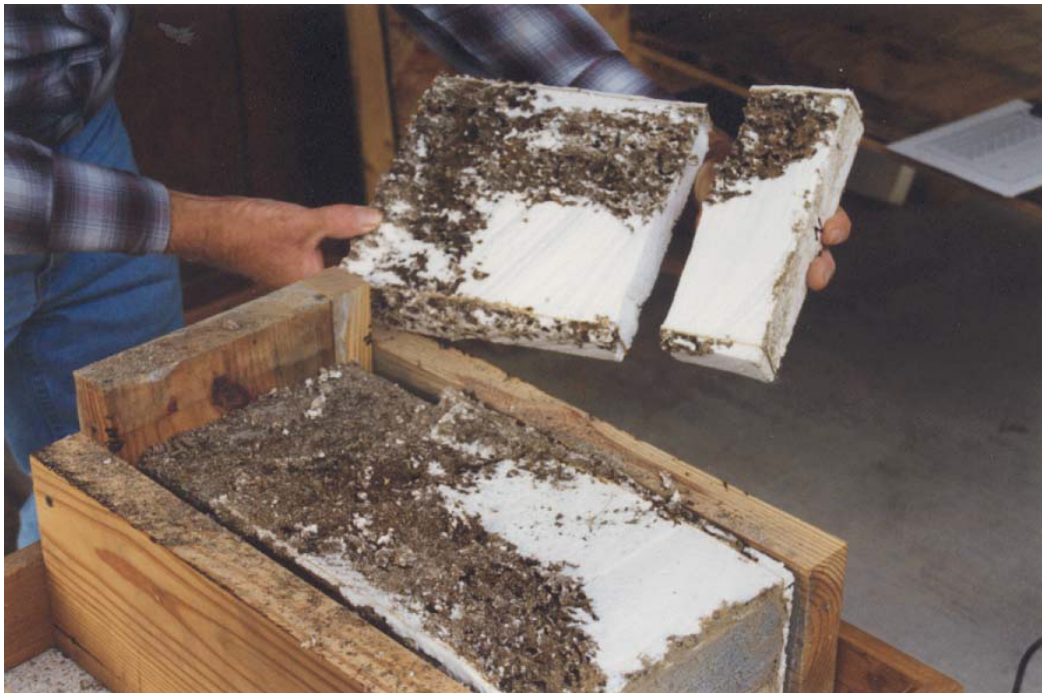
**#45 TEST FIXTURE - cut open to reveal extensive termite damage.**

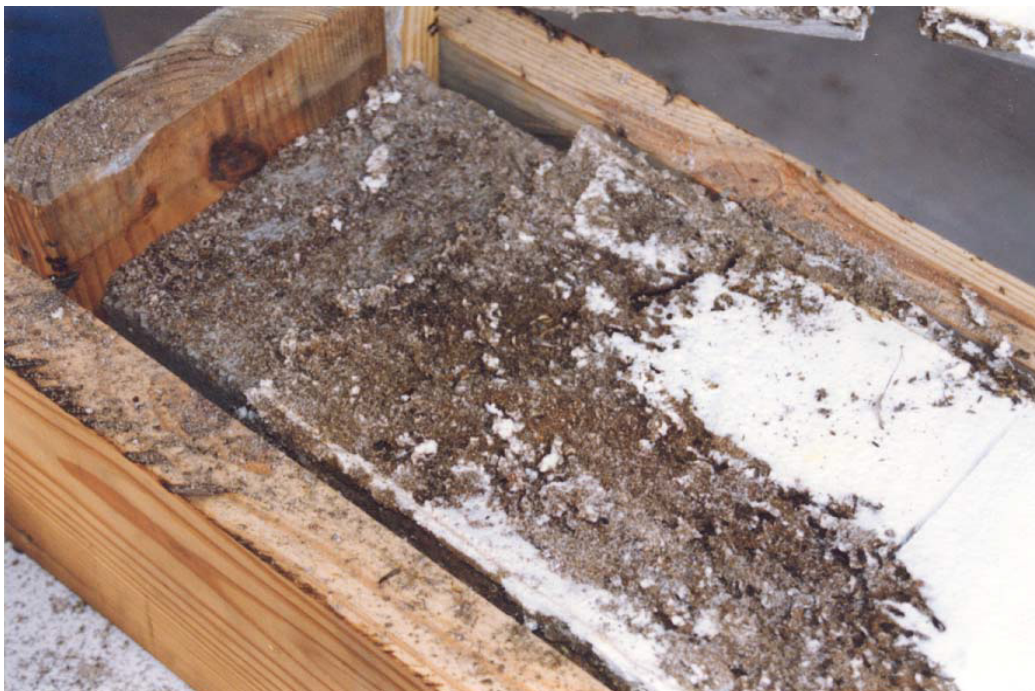
**#45 TEST FIXTURE - Close-up shows extensive termite damage.**

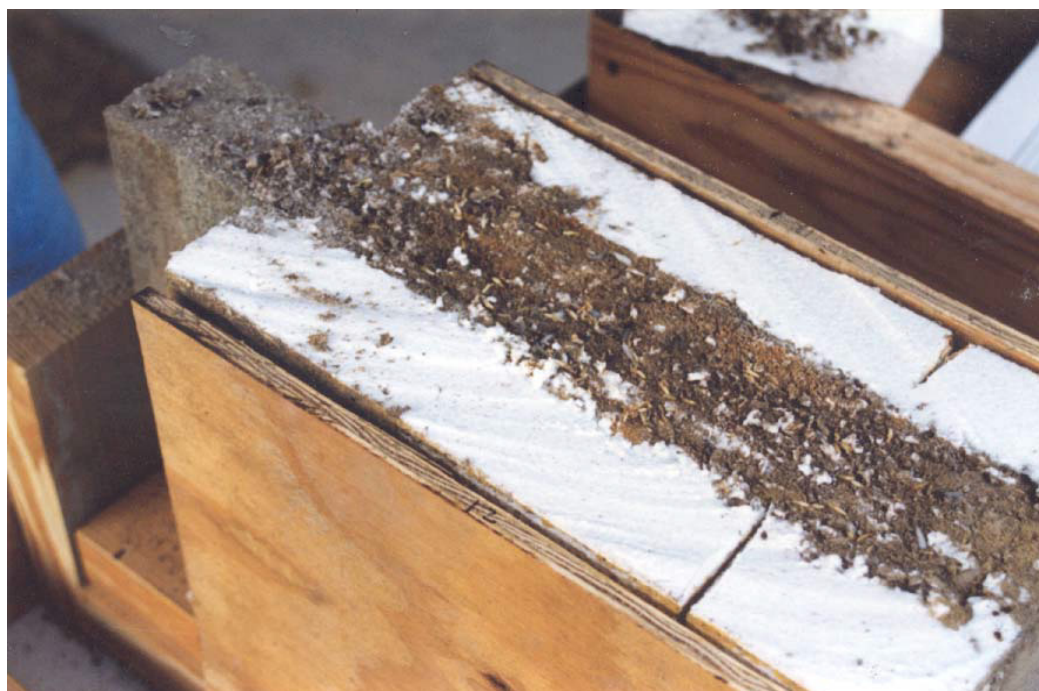
**#45 TEST FIXTURE - Close-up shows active termites.**

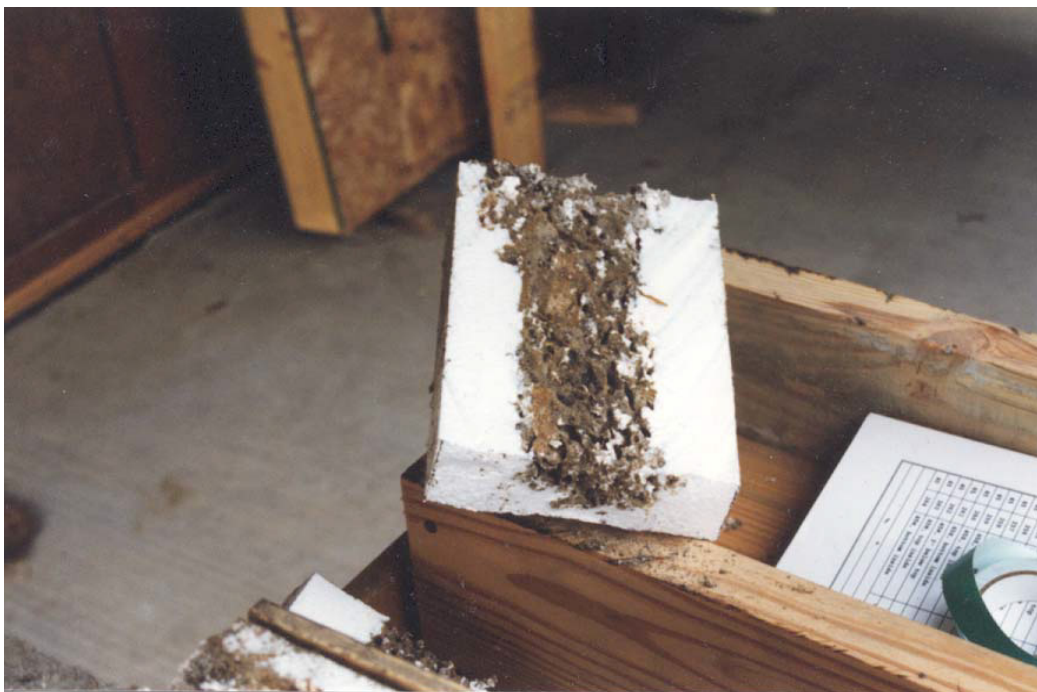
**#45 TEST FIXTURE - Close-up shows nesting infestation of termites.**

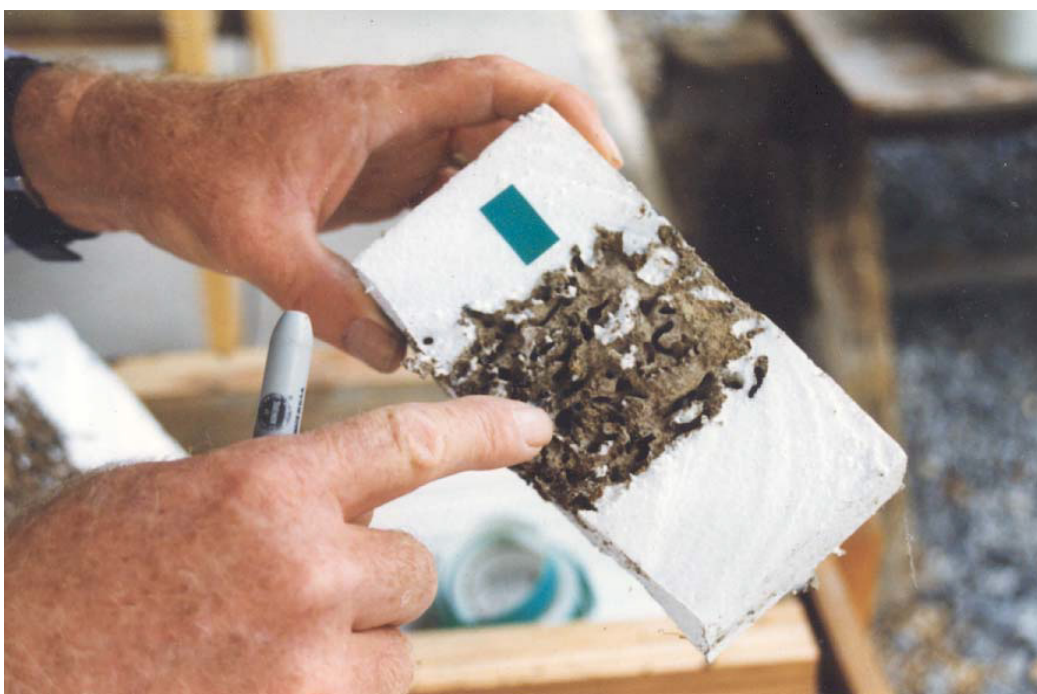
**#45 TEST FIXTURE - Close-up shows termite nesting galleries formed in non-treated EPS.**

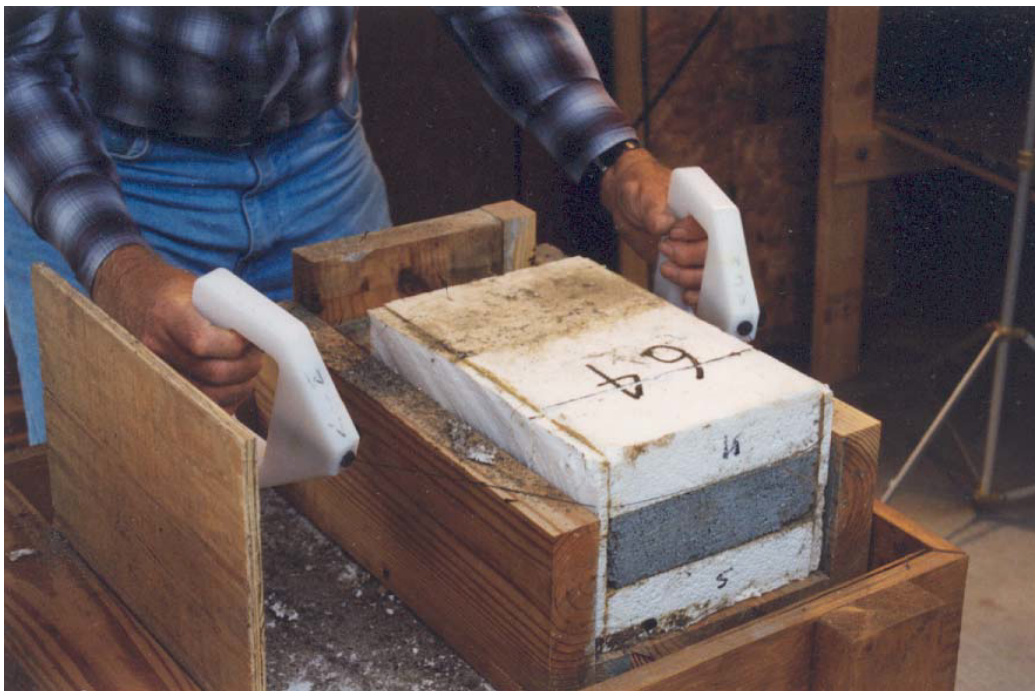
**#64 TEST FIXTURE - Examination of ThermaFoam R-Control with Perform Guard after 3 years exposure. Highland site, Mississippi.**

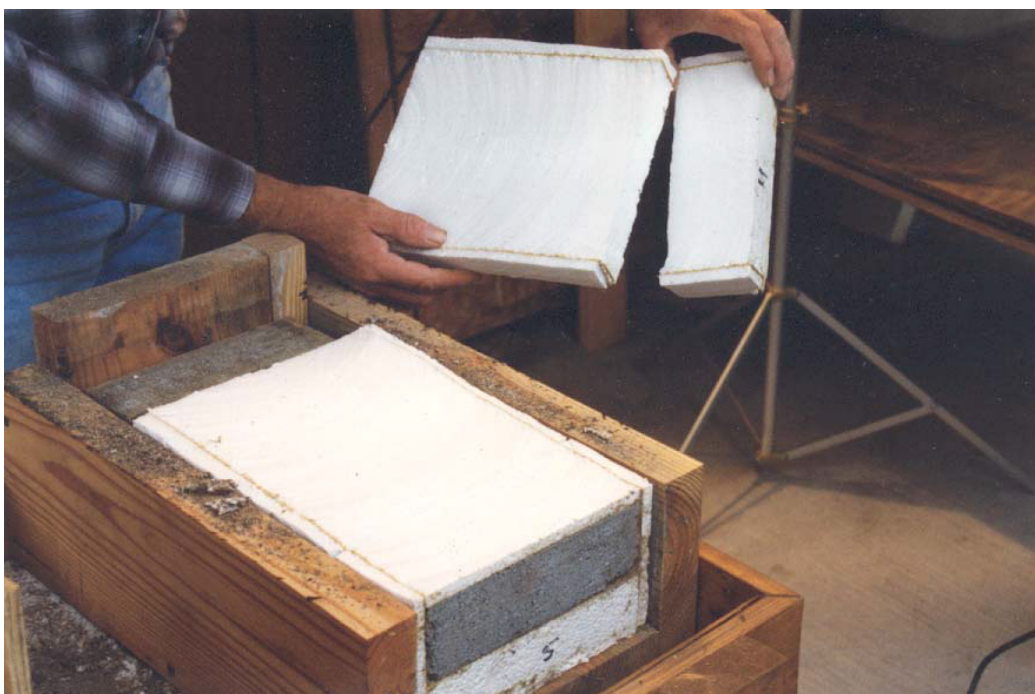
**#64 TEST FIXTURE - cut open to reveal limited termite damage.**

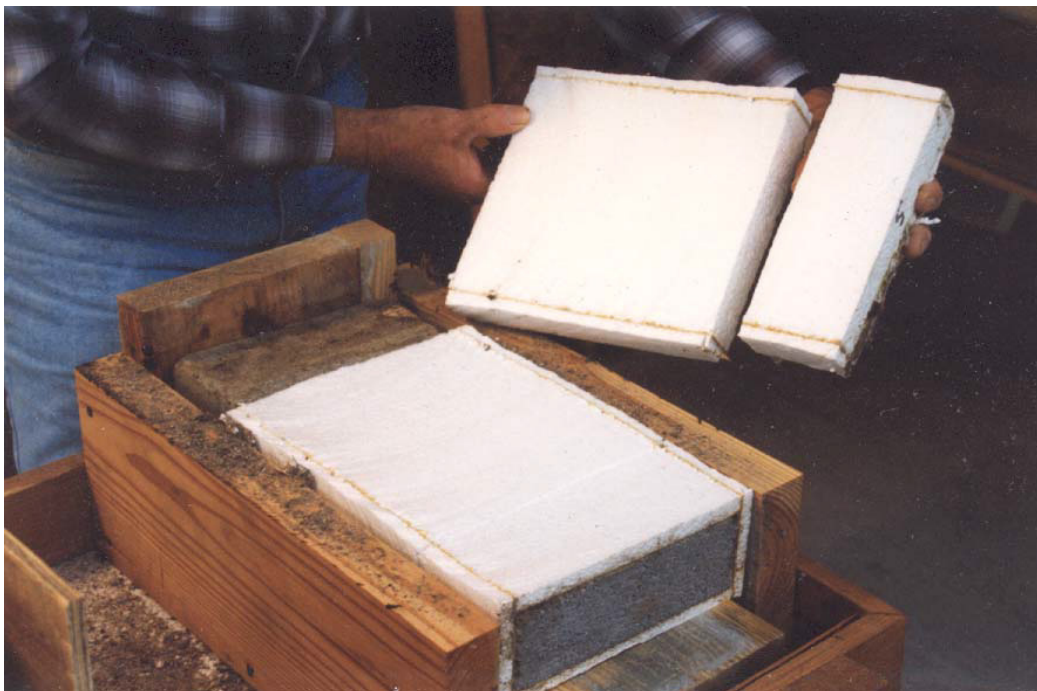
**#64 TEST FIXTURE - Close-up shows no termite damage.**

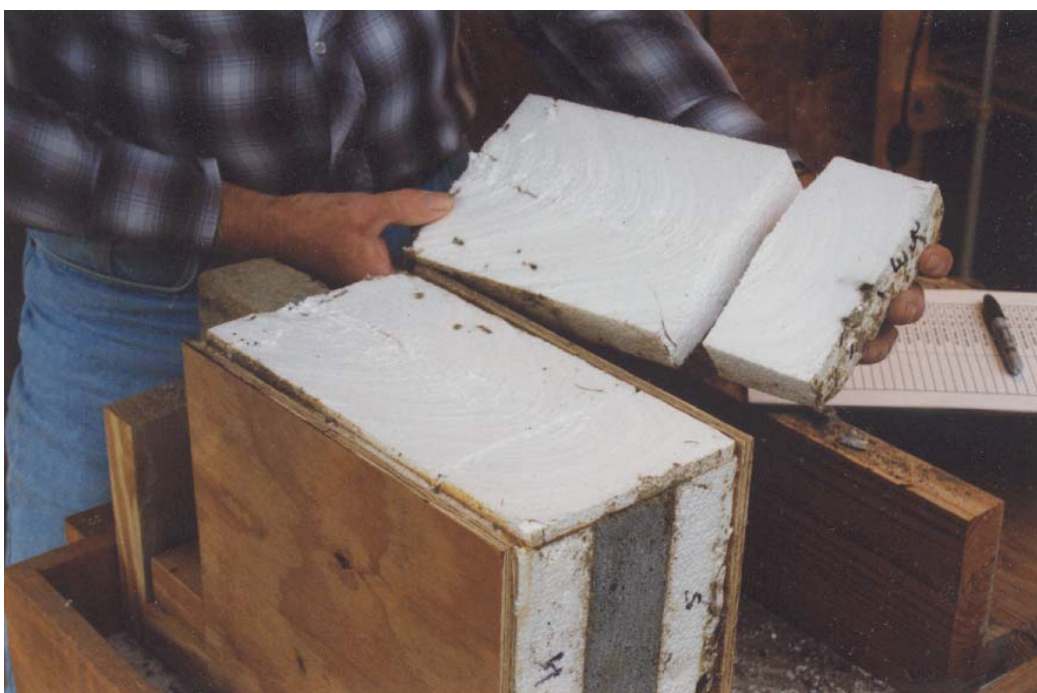
**#64 TEST FIXTURE - Close-up shows slight termite damage.**

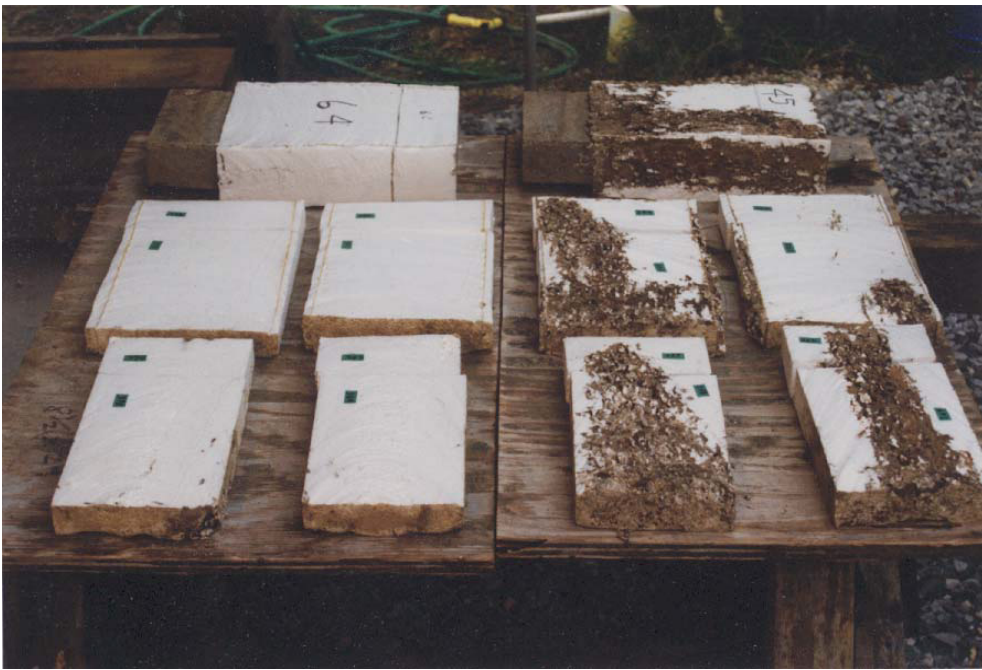
**#64 TEST FIXTURE -  
ThermaFoam R-Control with  
Perform Guard and R-Control  
Do-All-Ply.**

**#45 Test Fixture -  
Non-Treated MPS and standard  
construction adhesives.**

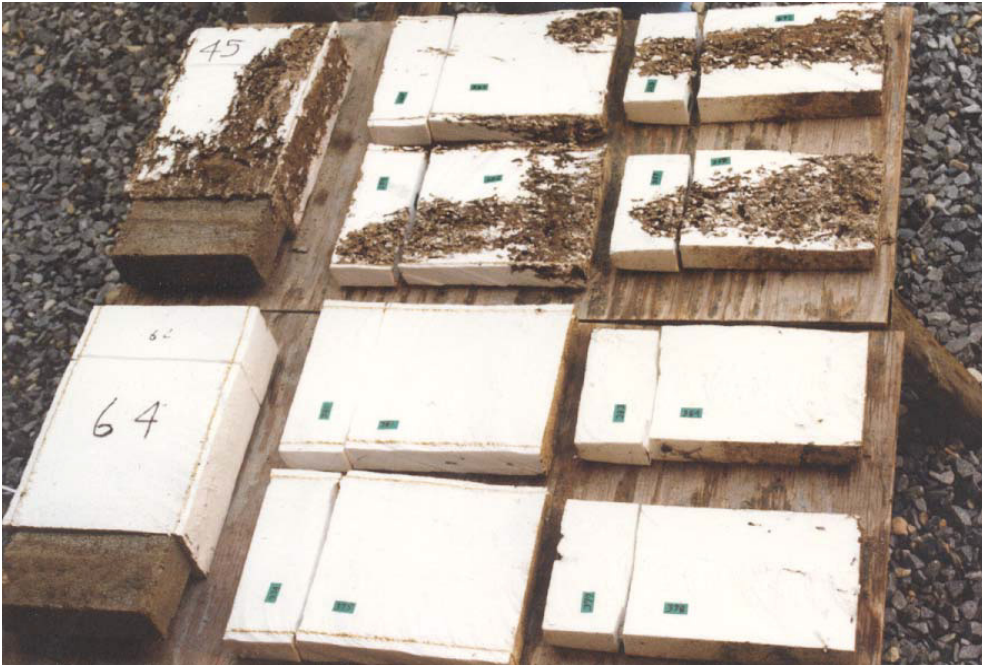
**#64 and #45 TEST FIXTURES - Close-up comparison.**
